CAST Analysis of the Buncefield Incident

Jamie Elliott

Buncefield, UK - 11 December 2005

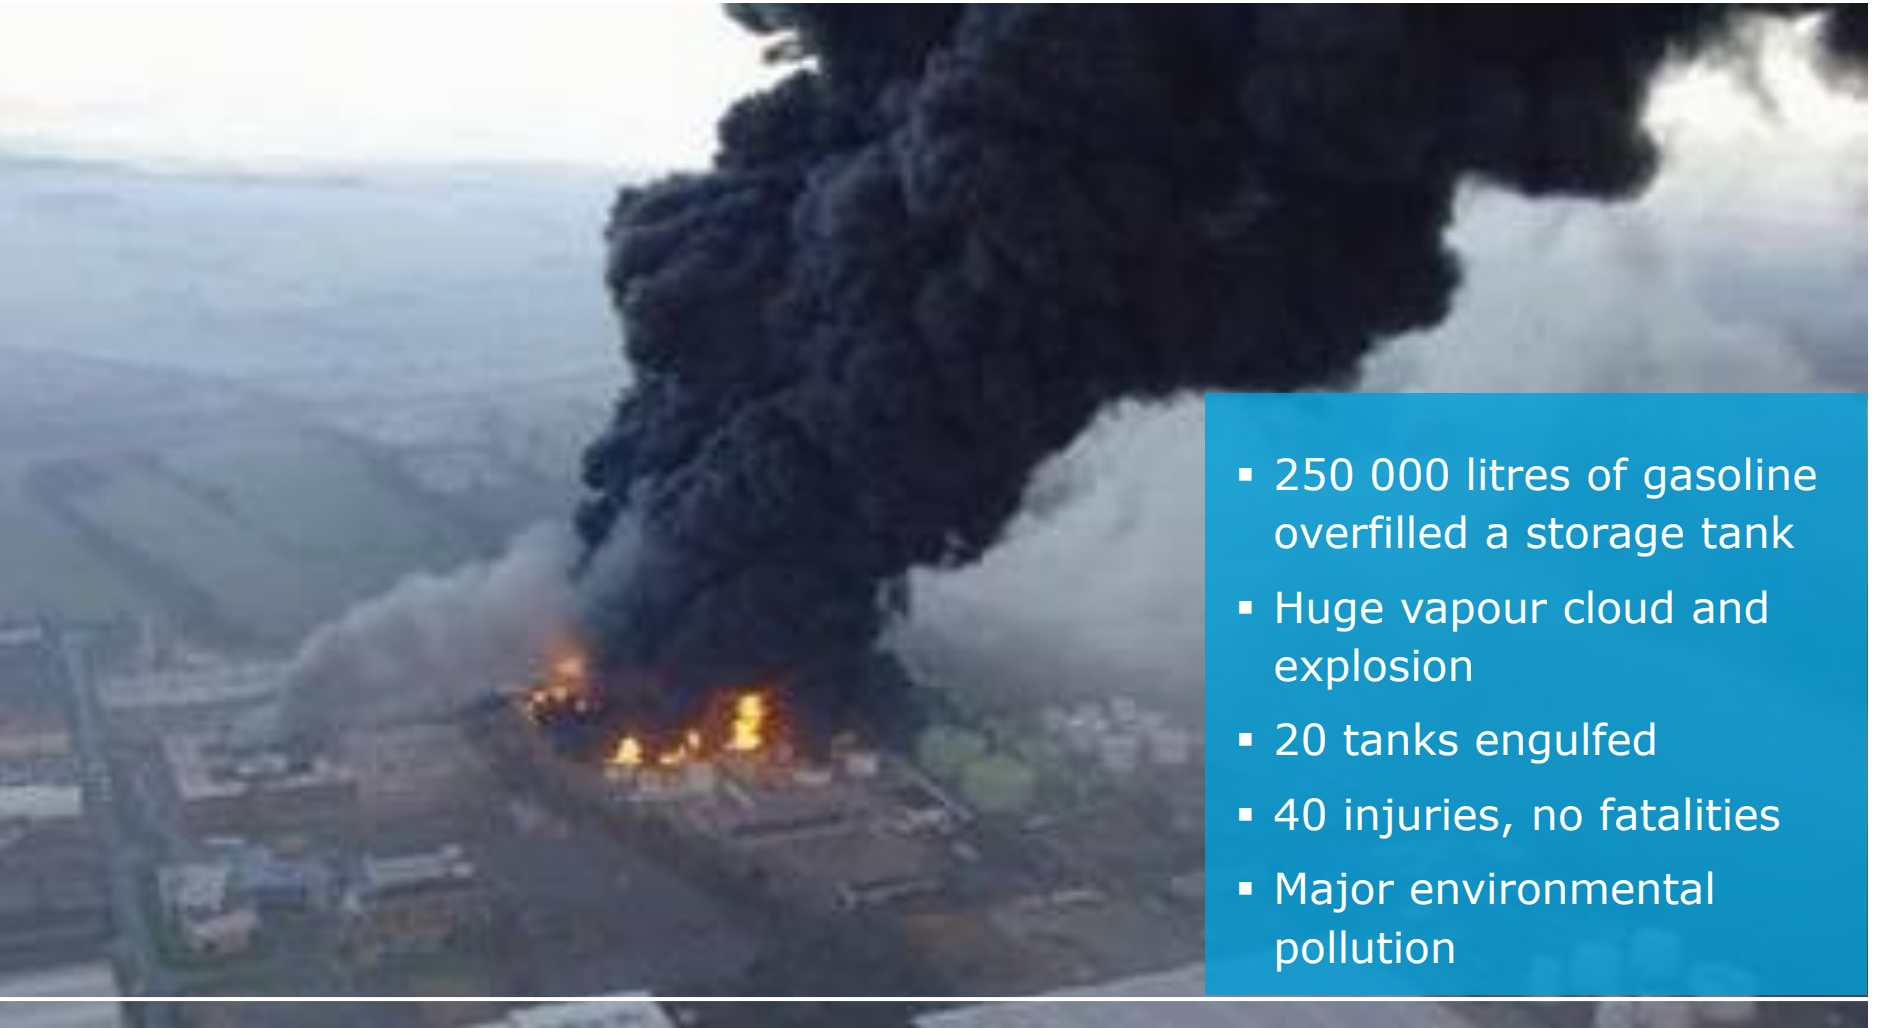
- 250 000 litres of gasoline overfilled a storage tank
- Huge vapour cloud and explosion
- 20 tanks engulfed
- 40 injuries, no fatalities
- Major environmental pollution

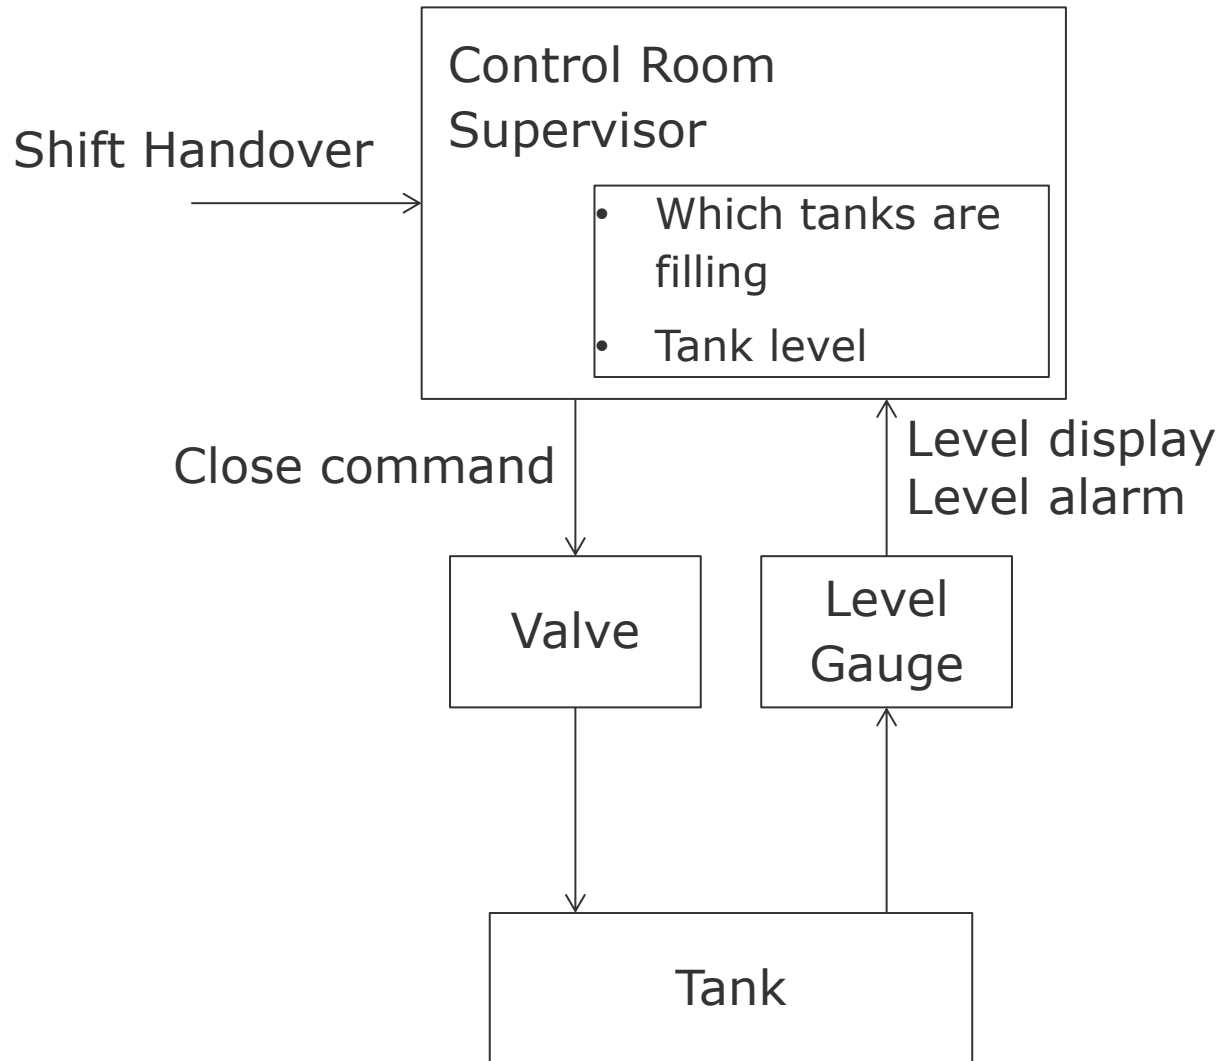
Level gauge did not work

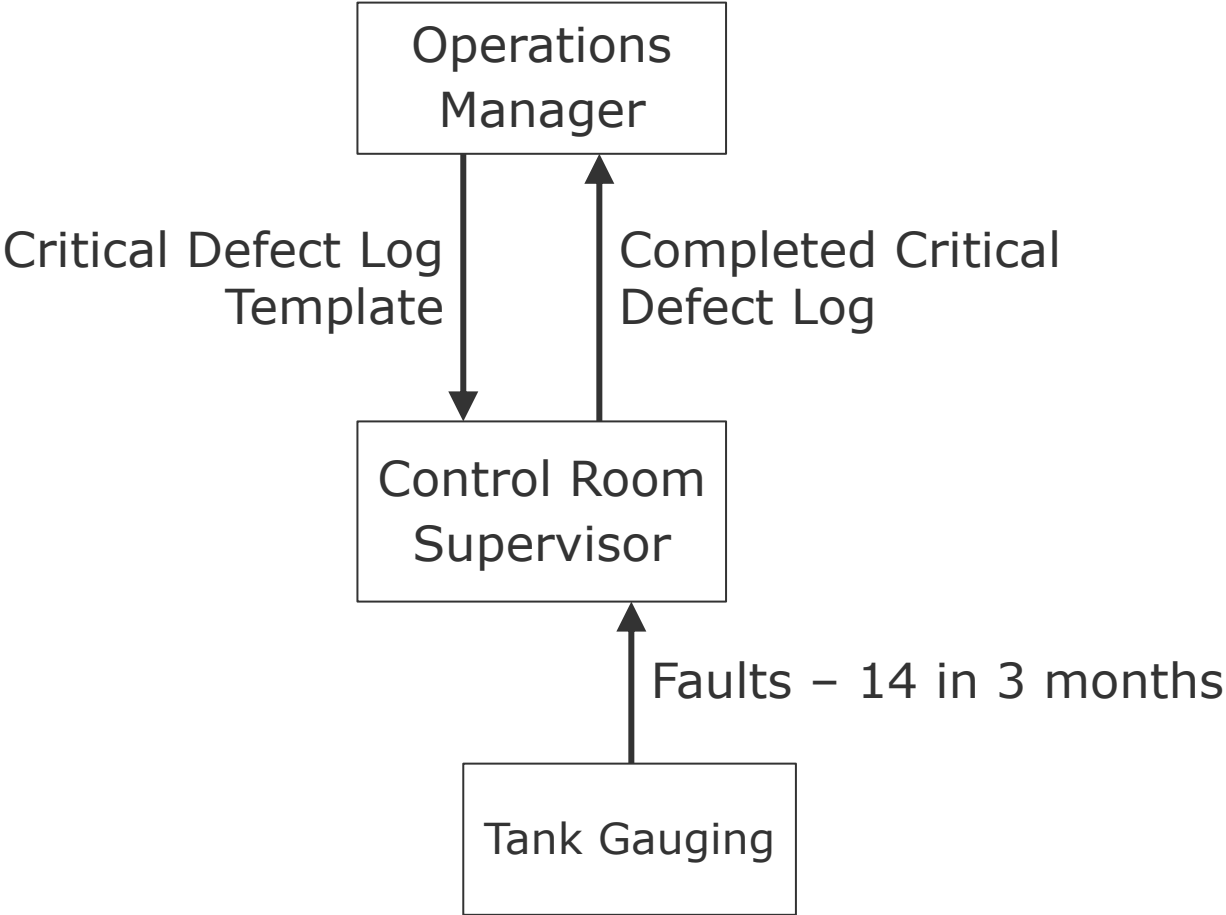
Defects not communicated

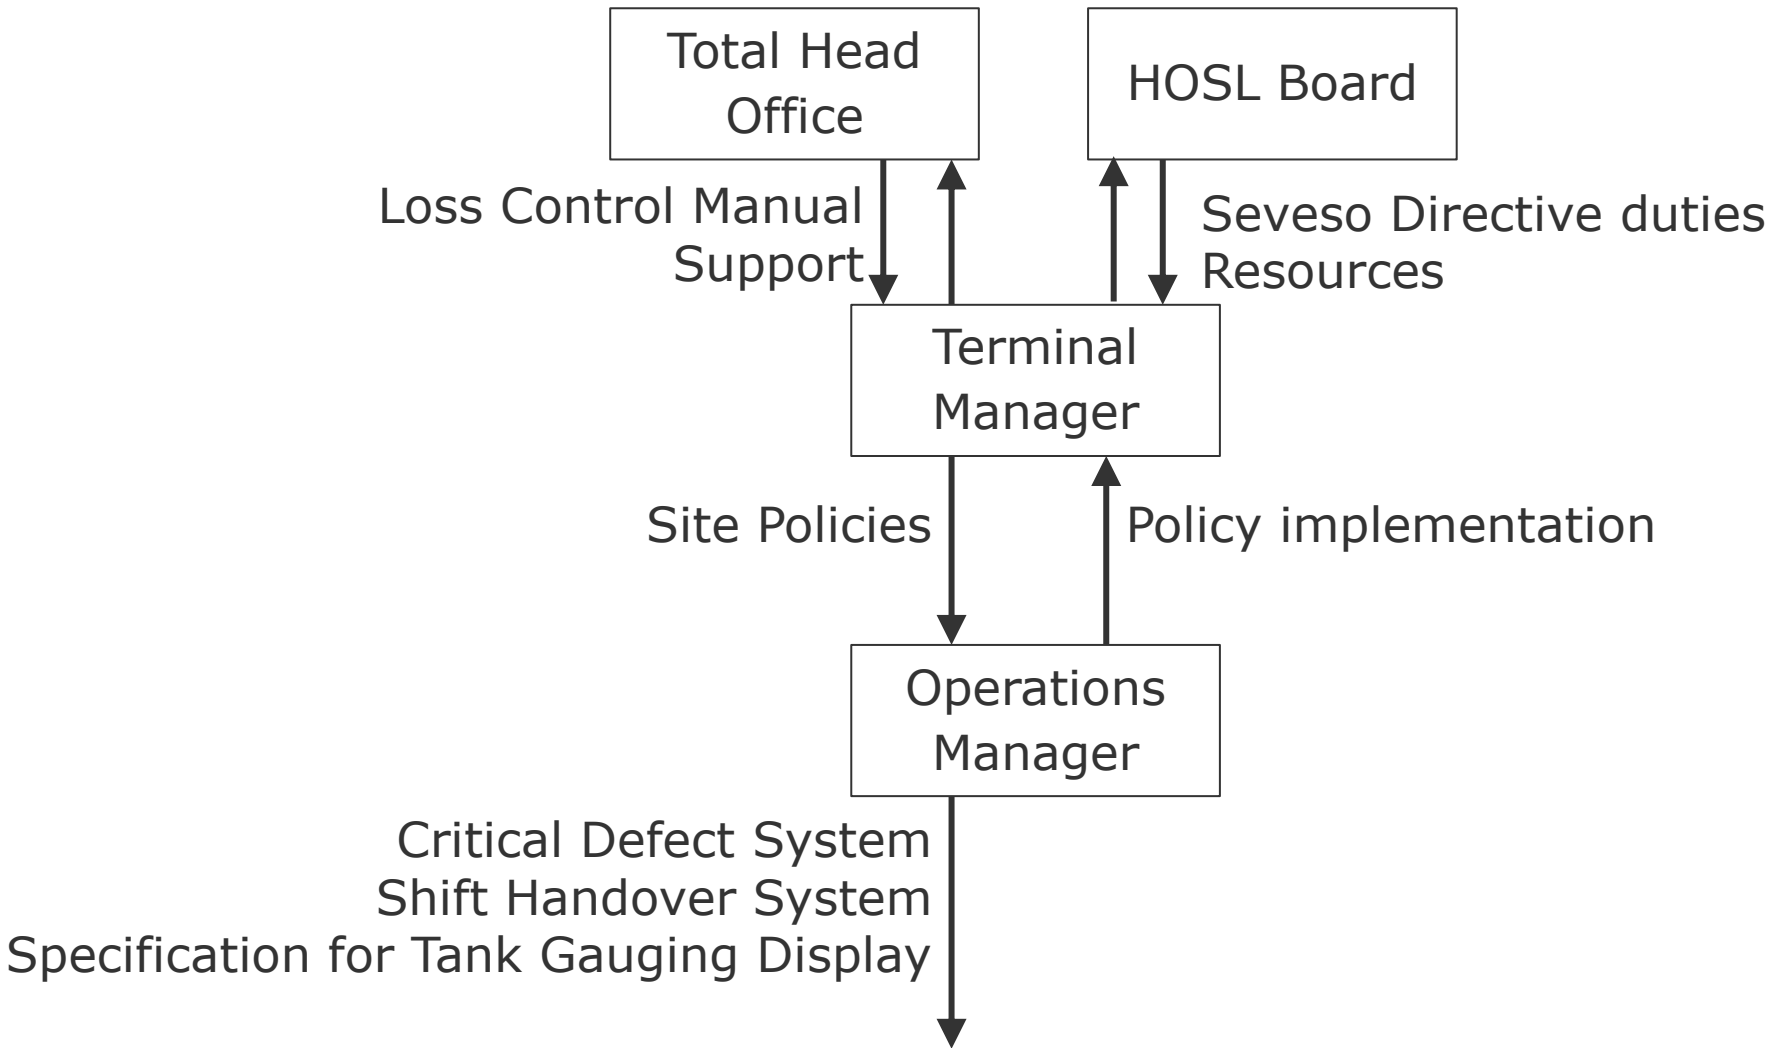
Overlapping responsibilities

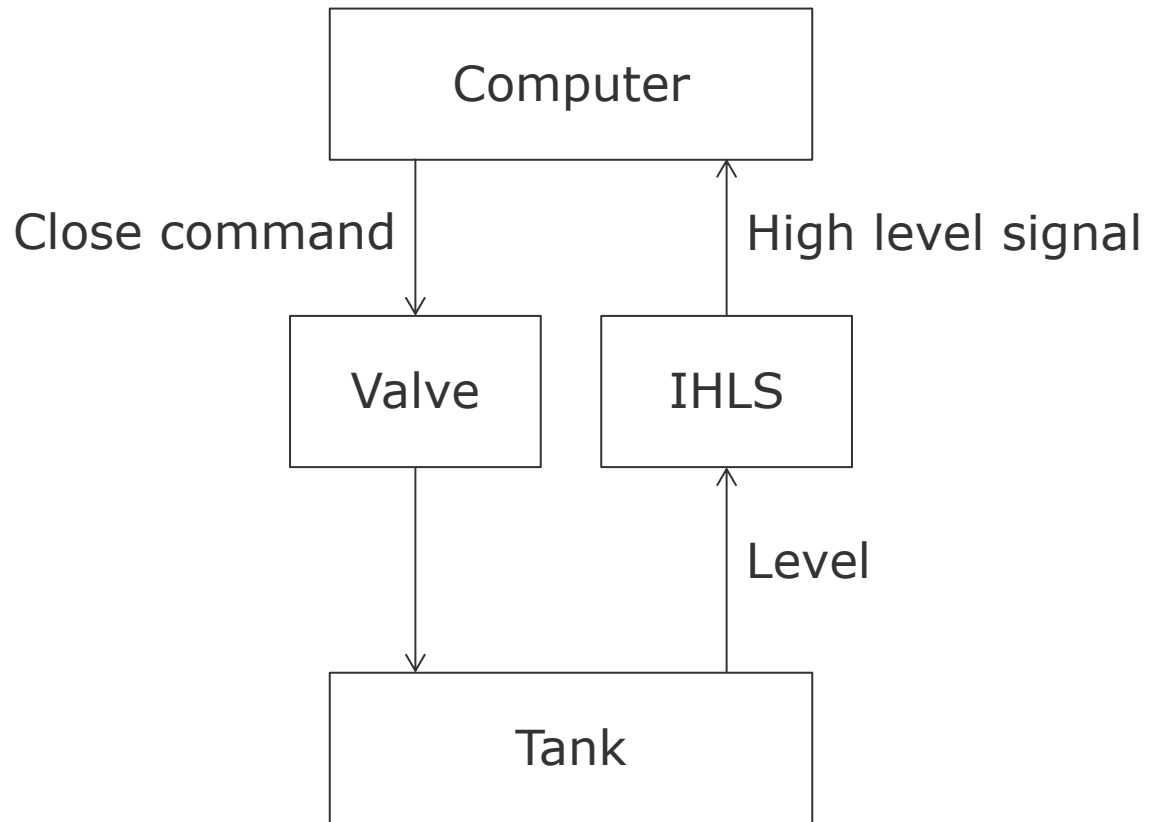
Independent High Level Switch (IHLS)

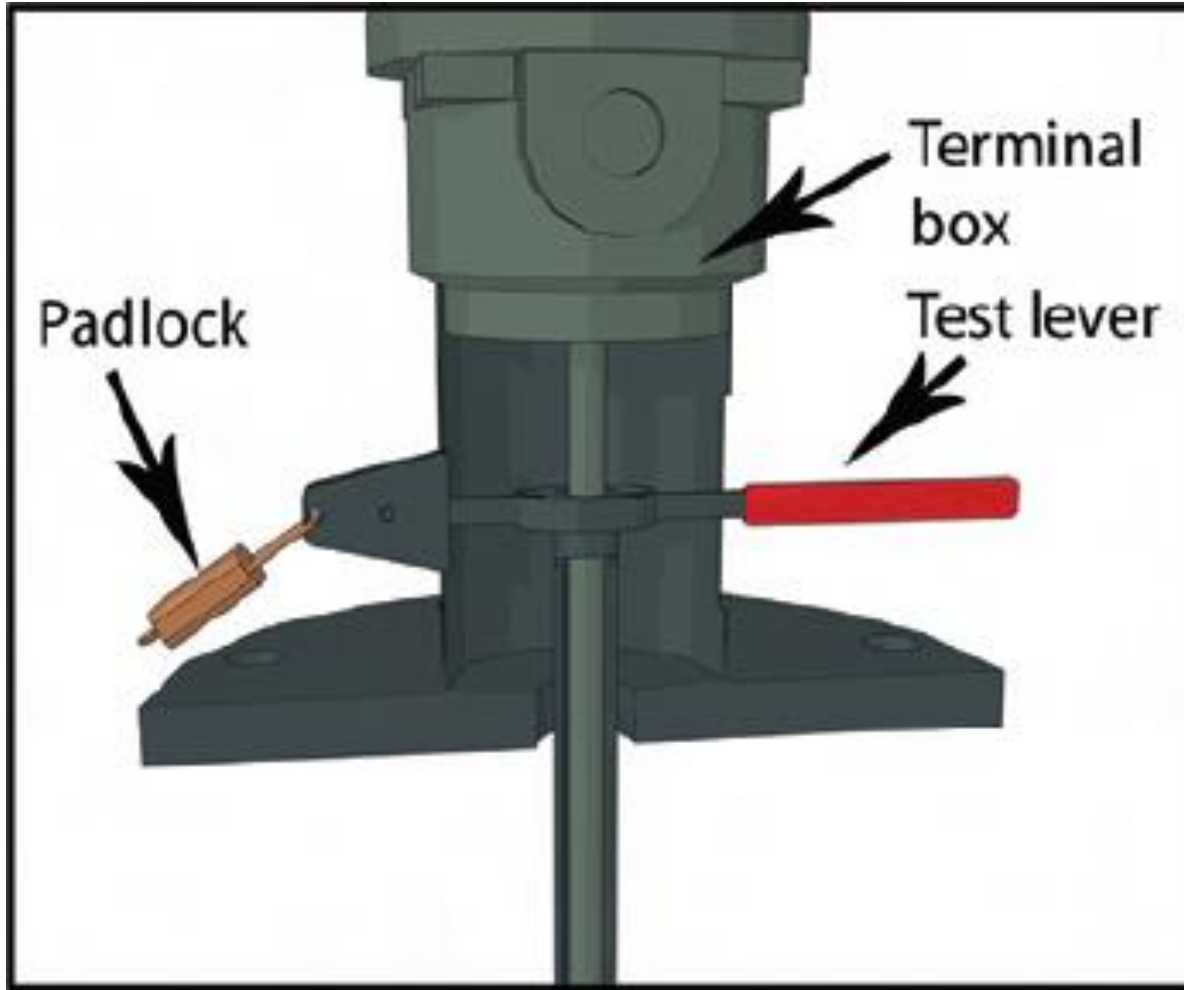
IHLS - The padlock problem

Rationale: To prevent the test lever from falling or being left in the test position, which would inhibit the functioning of the trip in the event of a real high level.

1. Replace the padlock on the IHLS after testing.

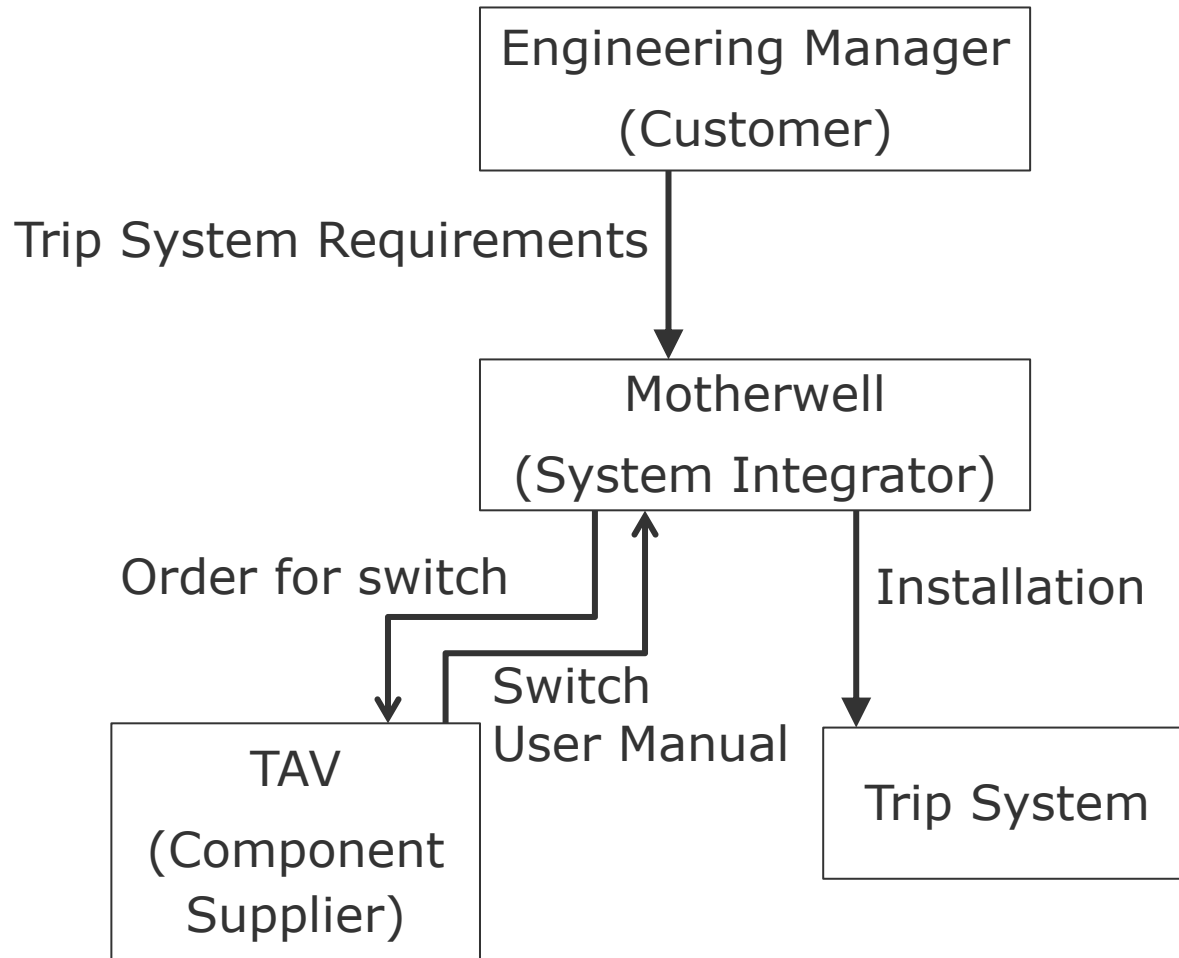
Contracted out engineering
