## Layout, detail design, manufacturing, and field testing of a UGV for agricultural applications

The present work includes the layout and detail design, manufacturing and field testing of a UGV for agricultural applications and is based on the focus project PA13\_hsbh\_5.

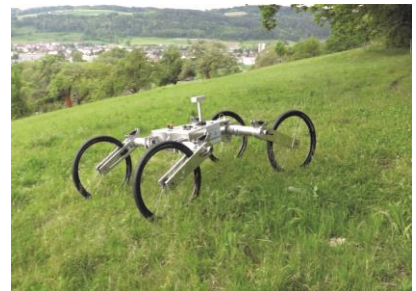
Prototype performing testing  
procedures

First tests were successfully performed. The UGV showed smooth running conditions and stable steering behaviours even on rough and sloped fields. Thus the UGV complies with the core requirements. An additional test was performed on a rough, sloped meadow at maximum speed. The drive trains showed unexpected rough running conditons and therefore caused damage to the chain drive. The design of the chain drive was altered in order to address that weak point. The field tesing will be continued after arrival of the required replacement components. After tests of the new drive train design the UGV is ready for pay load integration.
