CAST Analysis of the Buncefield Incident

Jamie Elliott

Buncefield, UK - 11 December 2005

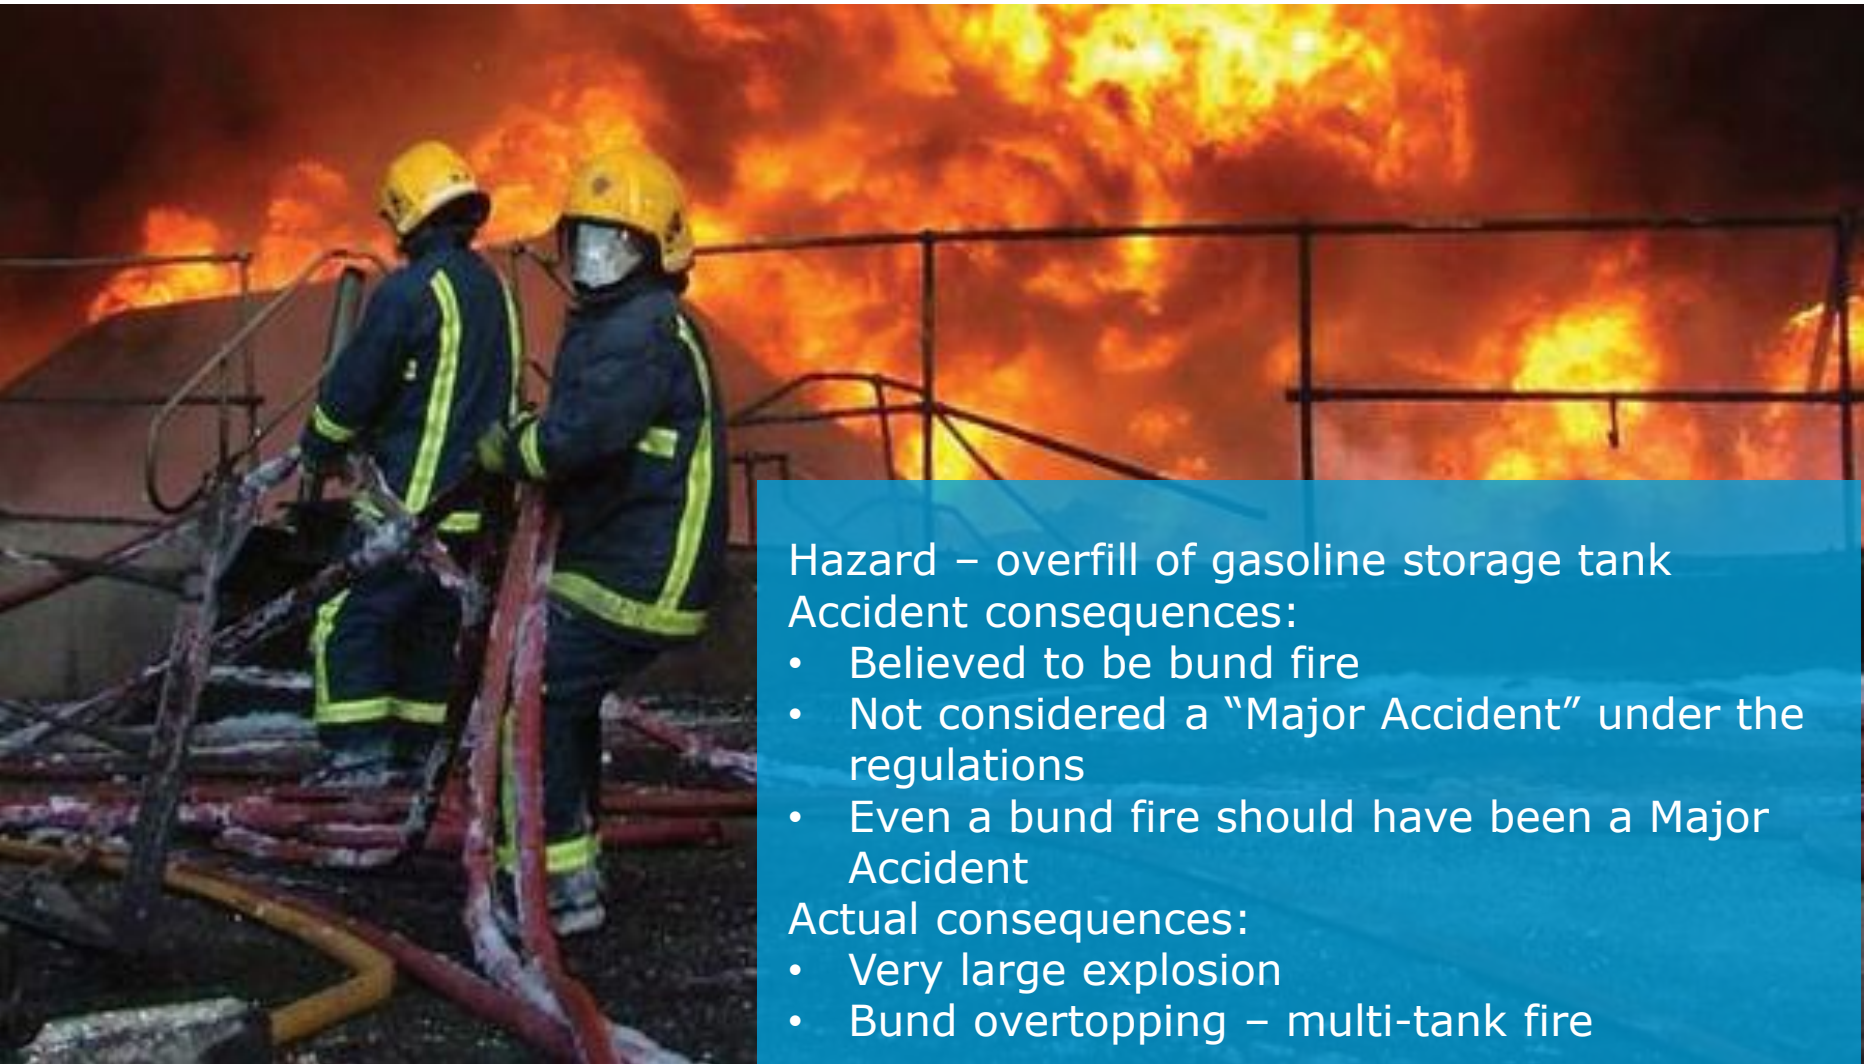
Accident consequences not recognised

Hazard – overfill of gasoline storage tank

Accident consequences:

- Believed to be bund fire
- Not considered a “Major Accident” under the regulations
- Even a bund fire should have been a Major Accident

Actual consequences:

- Very large explosion
- Bund overtopping – multi-tank fire
